HiPer Lite+ Battery Replacement

Many thanks to Jon Payne for his outlined procedure at *Surveyor Connect* forum¹ for replacing the batteries in the Topcon HiPer Lite receivers. I followed Jon's outline, taking some photos along the way, while also adding a few notes where applicable.

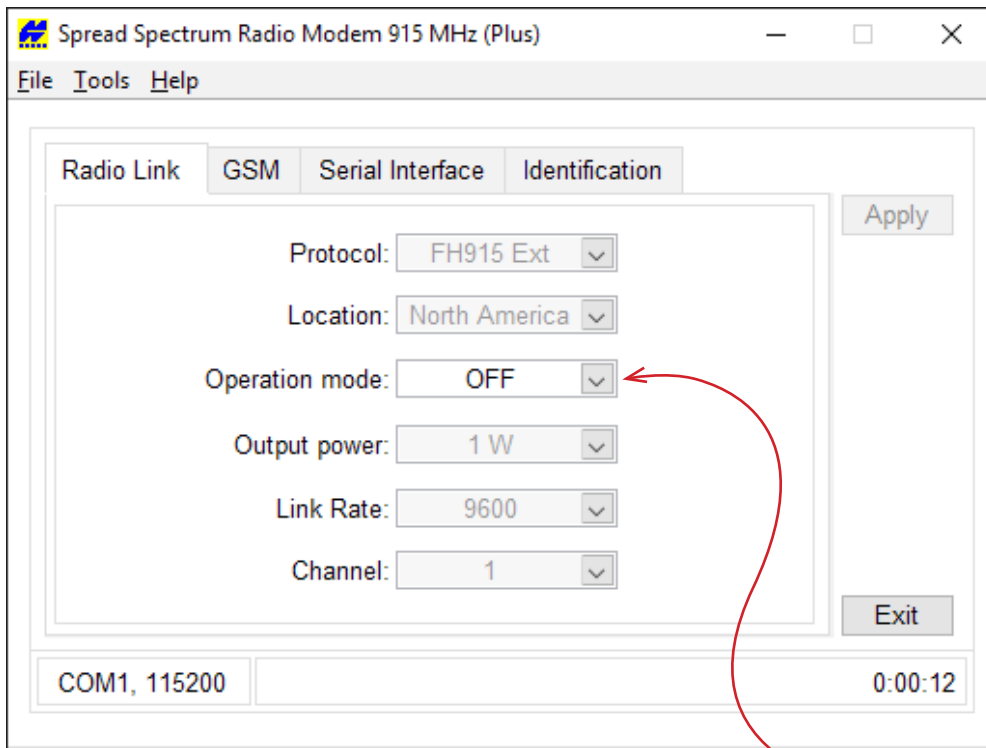
Before replacing the (2) internal batteries² on just the base unit, using Modem-TPS³, I turned off the radios on both the rover and the base. After the batteries have been replaced and fully charged, don't forget to attach the external antennas to the receivers and *then* turn the base and rover radios back on before doing RTK surveying. Alternatively, leave the radios turned off on both units if you plan on doing only static work and thereby appreciably extend the working time per charge cycle.

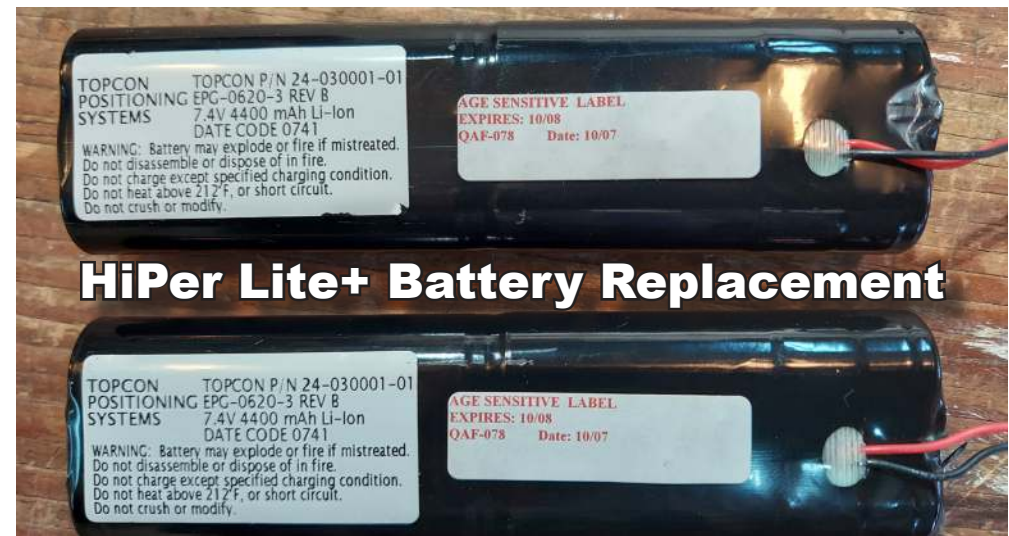
Before replacing the (2) internal batteries, using PC-CDU⁴, I set the Power Mode to External and turned off the power to all of the ports and slots. I don't know if this is necessary, but was done out of precaution. As will be shown at the end of this process, these settings are automatically reset.

Both Modem-TPS and PC-CDU are being run on an older PC (running Windows 10) which has a 9-pin serial port, and the serial cable was connected to

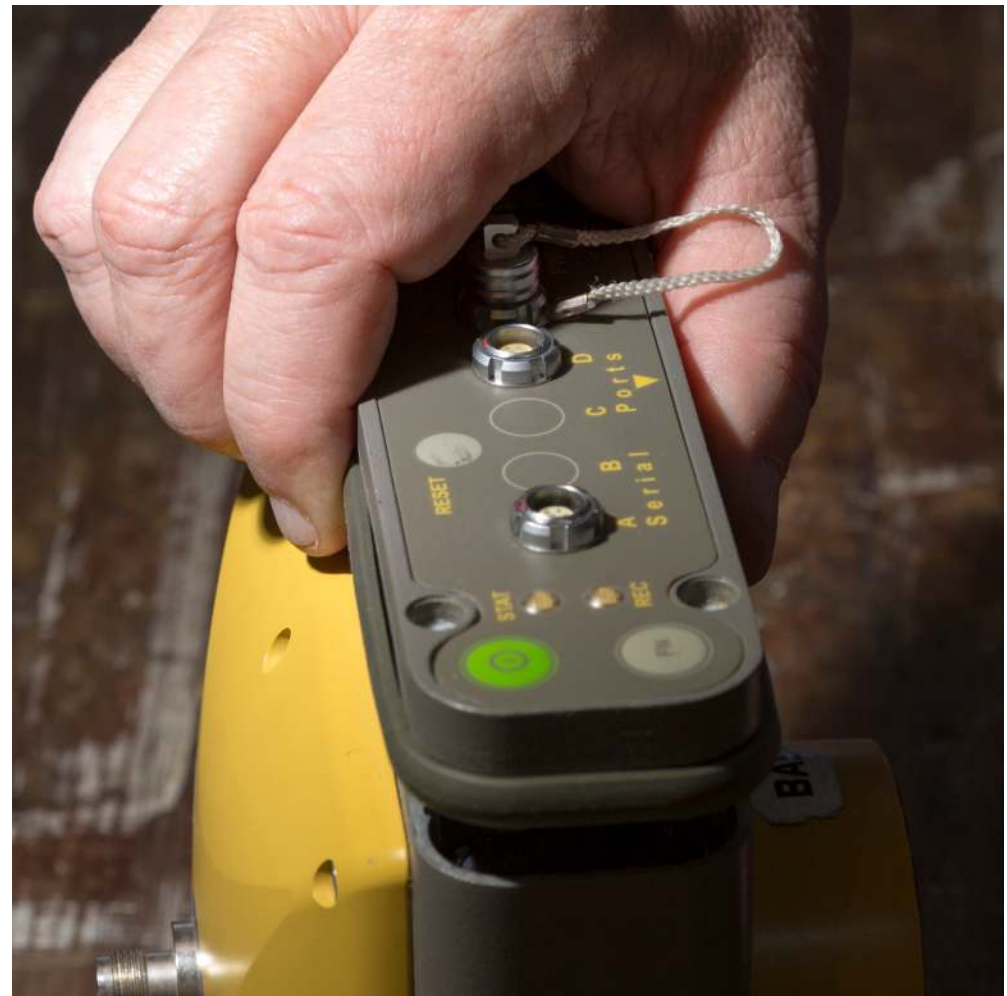
Face plate Removal

The numerous MINTER panel's pins need to be freed from their sockets on the receiver while keeping the gasket held in place against the face plate. This will help maintain the gasket's original position and shape while providing for a good grip. Holding the face plate by the rubber gasket, slowly begin pulling the front assembly away from the receiver working evenly with a slight back and forth rocking.

Once loosened, and before pulling the face plate assembly away from the receiver's housing, position the receiver allowing the face plate to rest on the work bench. As it splays open to reveal its connectors, pay attention to how the batteries' 2 pair of wires are positioned as well as how the two ribbon cables are tucked beneath the lower printed circuit board. You'll want to keep this image in mind during reassembly.

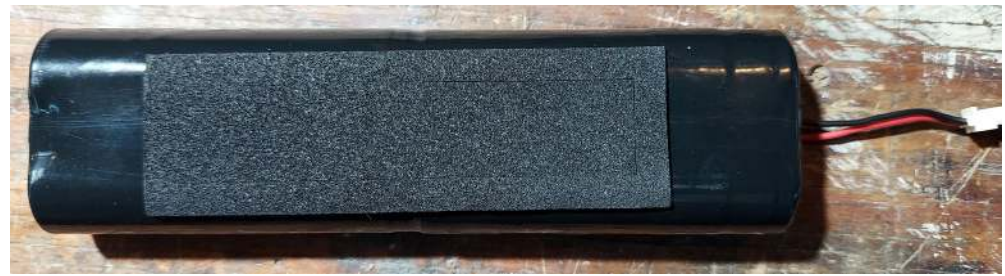
There's likely no need to pull either of the two printed circuit boards out from their slots formed by the rails in the receiver's housing; however, note that each battery has glued onto its outward face a strip of semi-dense foam. The foam is only attached to the battery keeping the battery snugly in place just by friction. Just keep this in mind as you pull out the batteries.

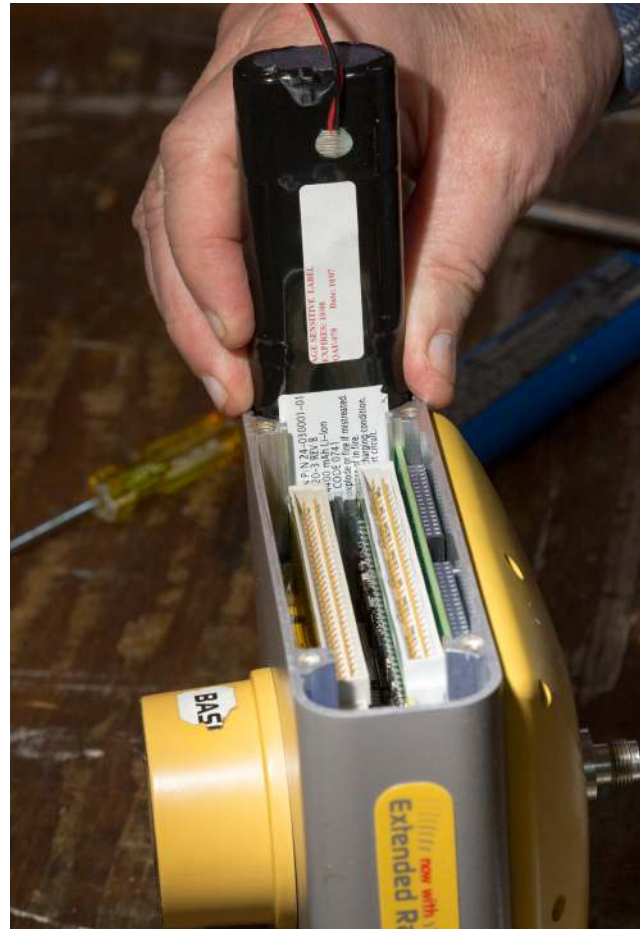
In addition to pulling on the battery's wires, I used a small screw driver wiggled beneath the exposed edge of the shrink wrapping to help coax the batteries out.

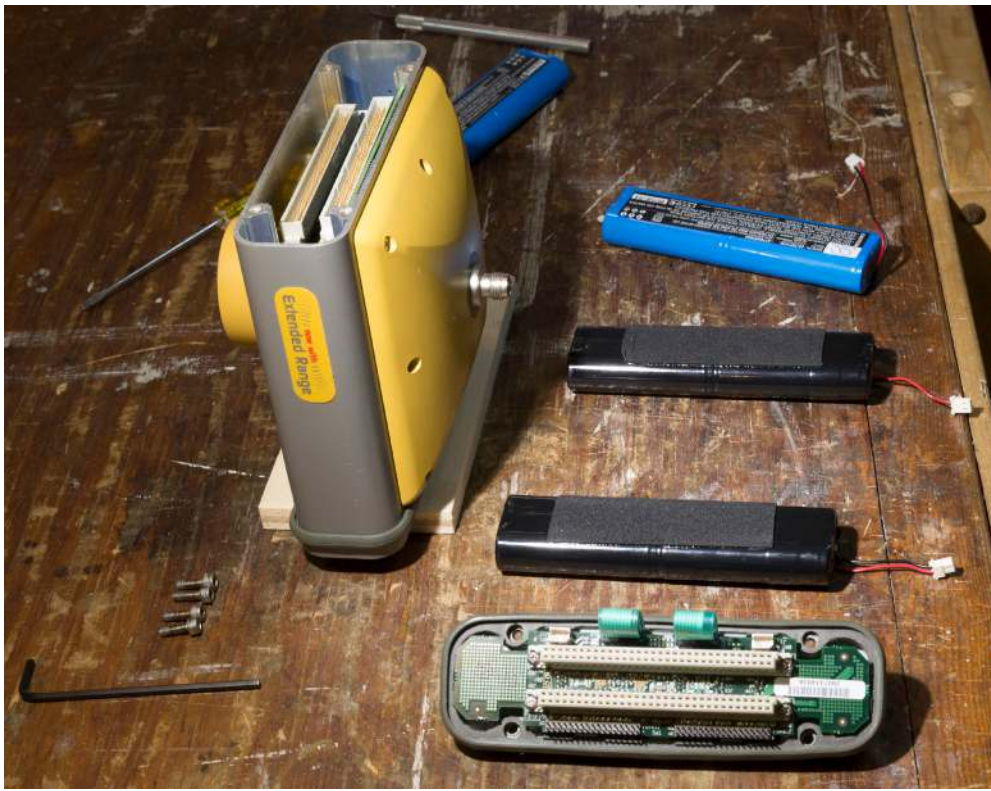
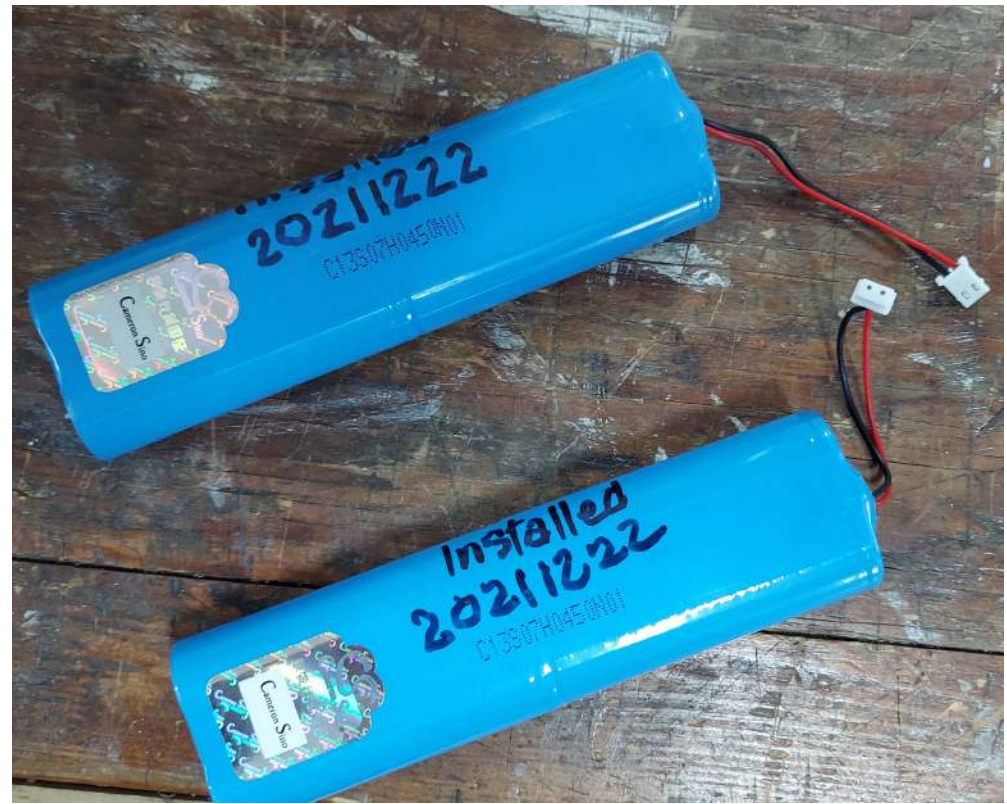
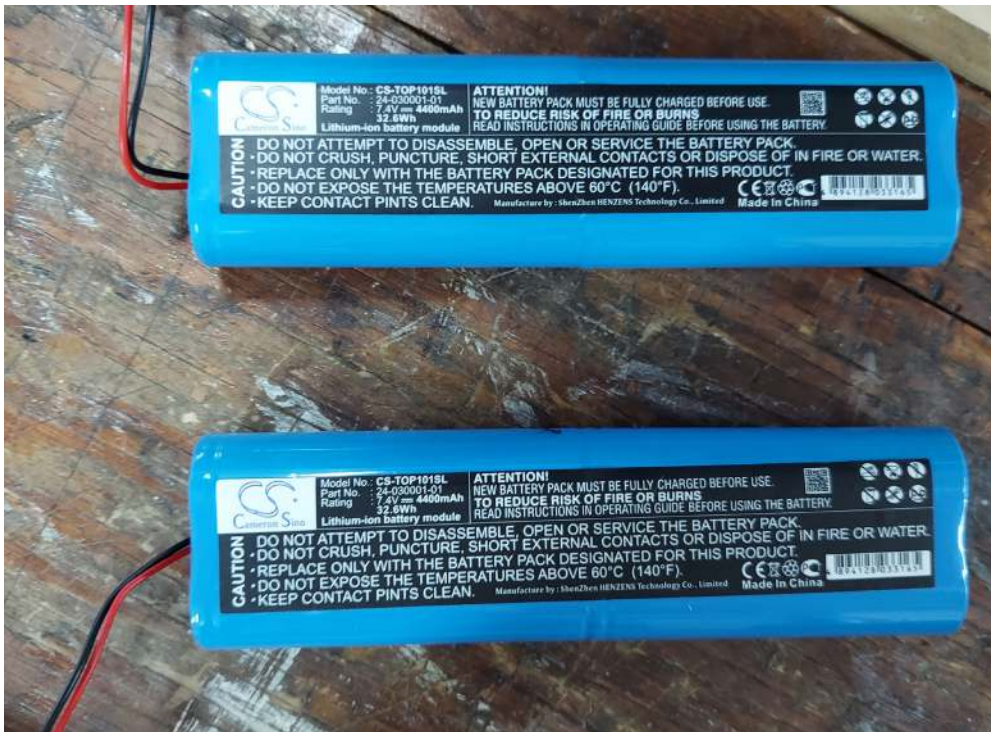
A few photo before the new batteries were inserted.

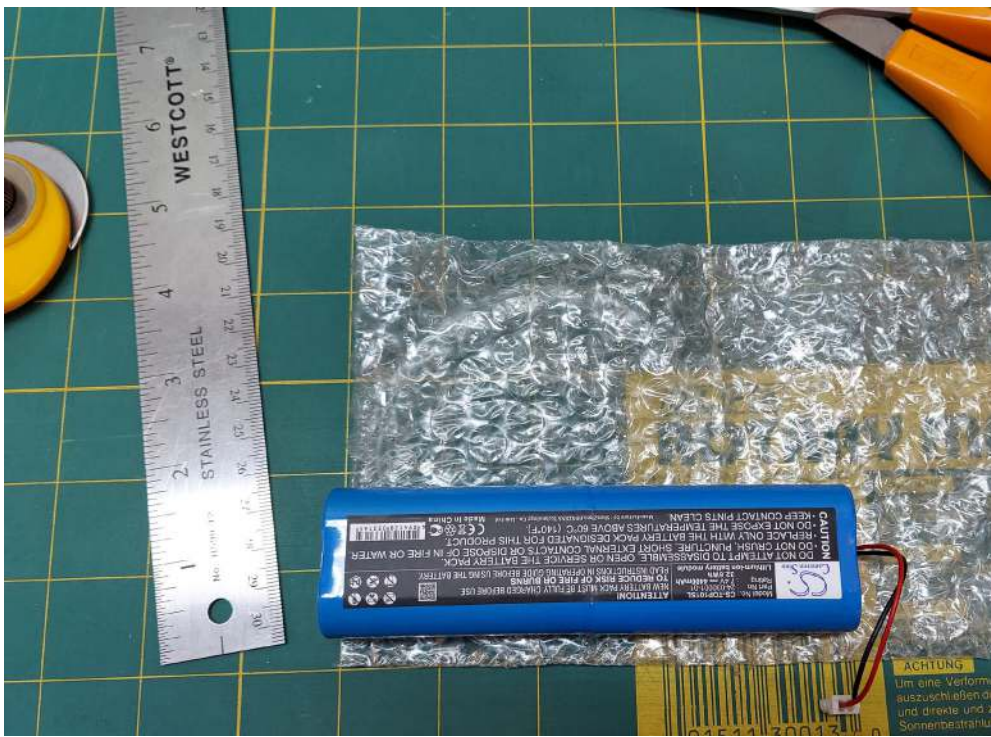
Preparing the new batteries

The length of the wires are longer on the replacement batteries than the original wires by about 3 cm and there's no foam tape stuck to the new batteries.

If they're used as is, they will be loose, rattling and freely sliding in their compartments. In lieu of the foam tape, I cut an old bubble-pack bag, basically making a strip narrower than the width of the battery. The length of the strip is less than twice the battery's length. Then I wrapped the battery with the bubble side touching the battery and with the smooth side facing outward before taping it across the end of the battery.

Note, this was a used bubble-pack bag and ended up being thin enough to work perfectly without having to selectively pop any of the bubbles in order to make the fit snug, and yet not make the battery's insertion difficult.

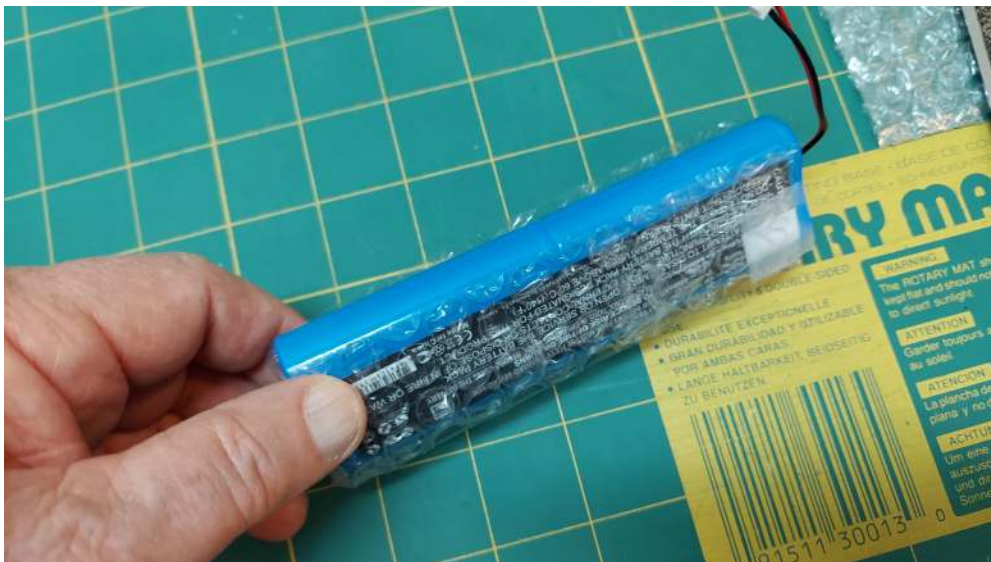
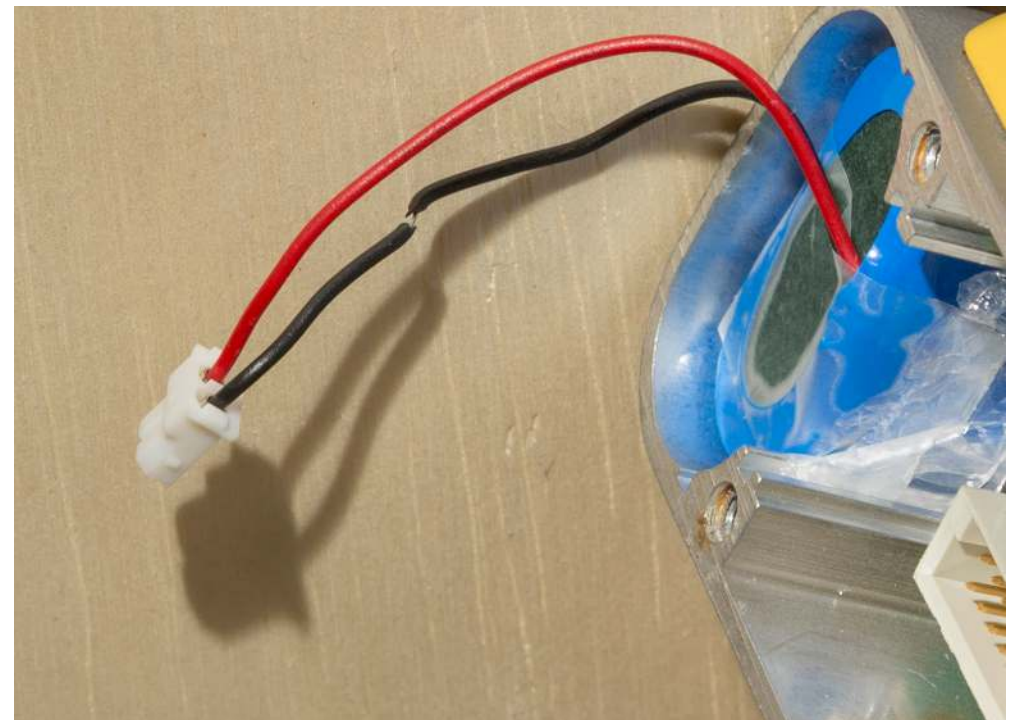
Be mindful of where the wires get placed

As mentioned by others, and as I found out too, it is easy to nick the wire's shielding on the sharp edges of the various components such as the plastic housing of the pin connectors, aluminum rails, and PCBs as seen in the photo below.

Fortunately, the nick was limited to the shielding and the wires inside were intact allowing for a mending rather than having to replace the wire.

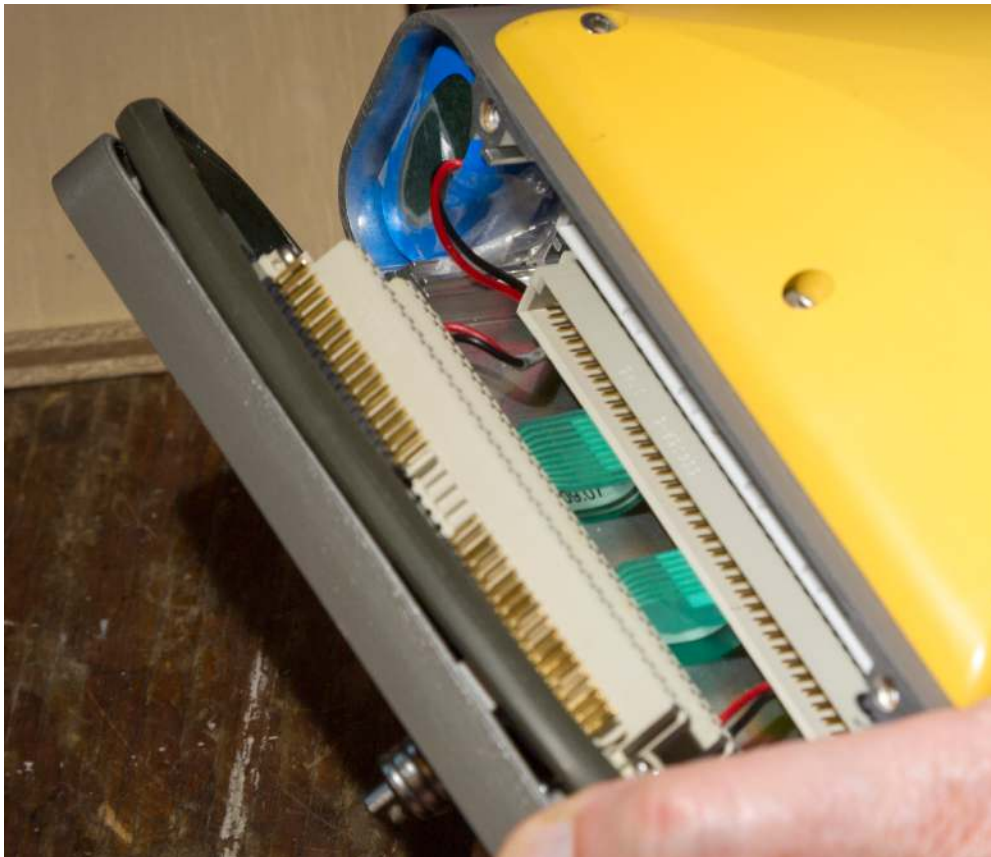
The surplus length of the wires needs to be tucked beneath the lower printed circuit board and at the same time the ribbon cables get likewise tucked away. Once you're certain of the placement of the wires and cables, bring the face plate MINTER assembly squarely aligned with the receiver and begin inserting the pins into their sockets.

At the same time as you're gently pushing the pins in, pay attention to keeping the rubber gasket aligned and in the correct position as the front plate assembly fully seats itself with the receiver. Once the pins are in contact, don't be surprised seeing the BATT LED begin flashing on for a second.

Before re-installing the screws; *and without any sealant just yet*, make certain the gasket is uniform in appearance all around. The screws ought to drop into place with little to no effort if everything is properly aligned. Finish seating the pins by fully screwing the assembly together.

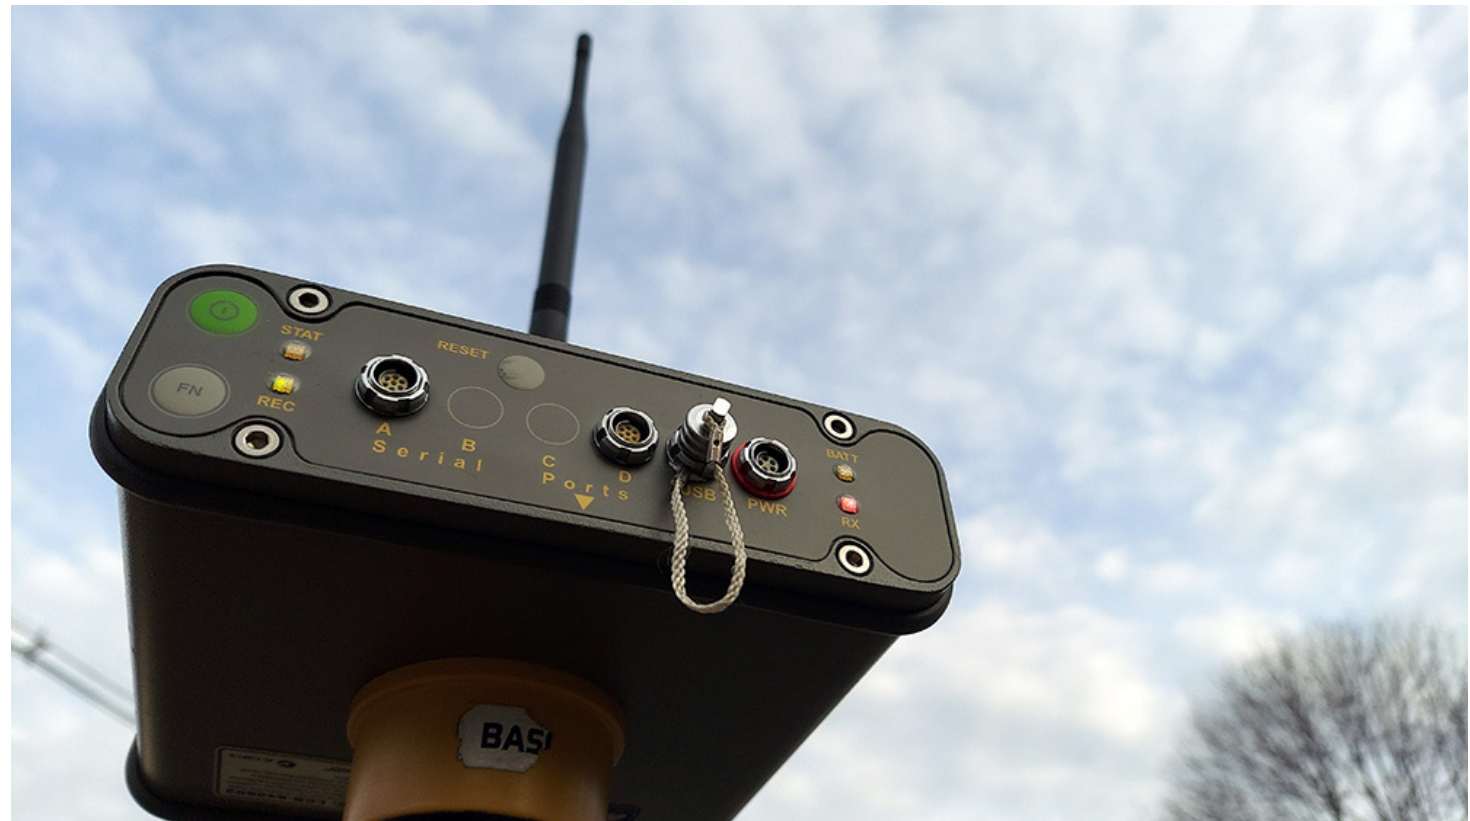
Receiver model: HIPER
Receiver ID: 8QP36KDB2TC
Firmware version: 3.5 Feb.01,2019 p5
RTK support: yes
Mainboard version: HGGDT_7
RAM size: 4096KB
Power Board: hw=4, fw=44
Power supply (V): 11.6
Antenna input: int
Ext. Ant. DC status: off

Power source: auto
Power cur. source: ext
Charger status: auto
Charger cur. status: b
Battery A(V): 7.63
Battery B(V): 7.88
On board (V): 7.9
Charger (V): 7.91
On ports (V): 11.91
Charger current (A): 1.461

settings have all been reset to their default settings. Then turn off the receiver and allow the new battery to fully charge. These screenshots were taken right after the batteries had been replaced and prior to charging.

Power management
Power
Mode : Auto
Current Mode : ext

Voltages (volts)
External : 11.6
On Board : 7.9
Battery A : 7.63
Battery B : 7.86
Charger : 7.89
On Ports : 11.91
